## Seismic Response of Reinforced Concrete Structure with Infill Walls for Vertical Forest Applications - Seismic Table Tests

This paper presents the dynamic experimental results of a three-dimensional specimen tested on the seismic table of the Laboratory of Reinforced Concrete and Seismic Design of Structures of DUTH (Democritus University of Thrace). The specimen was constructed as part of the GREENERGY project with the aim of reintroducing vertical forests into existing approaches for repair and strengthening of reinforced concrete buildings. The one-storey test specimen consists of four columns supported on strong foundation beams anchored to the seismic table. The columns are connected at the upper level with hidden beams into a solid slab. The slab protrudes from all four sides at the upper horizontal level, as do the columns along the vertical direction. Furthermore, at the upper level, the beam-column joint has two special joint configurations: a typical one and one without a slab area and beam reinforcement anchoring into the joint region. The seismic excitation is applied in one direction of the structure where there is a partial infill wall eccentrically placed, while

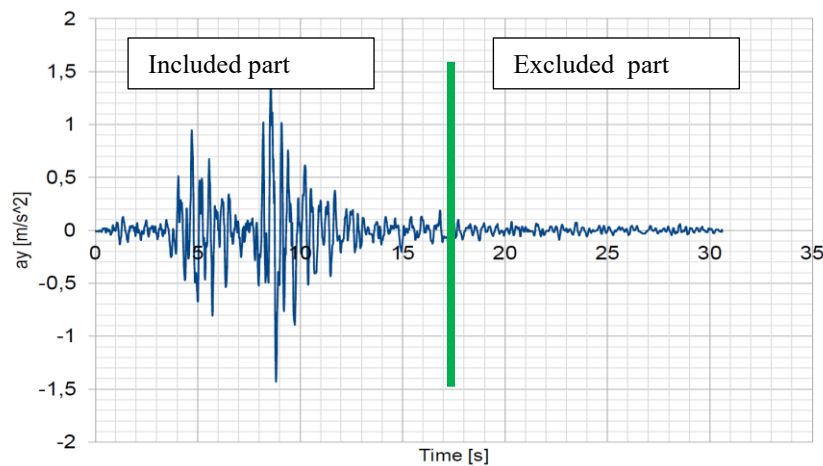
Figure 5: Time history executed (included part) by the DUTH seismic table ( $a_y$  component of Thessaloniki (Volvi) earthquake record)

The structure was subjected to a progressive seismic testing protocol using the  $a_y$ -component of the severe 1978 Thessaloniki (Volvi) earthquake as the base ground motion (see Figure 5). Five scaled intensity levels were applied sequentially, ranging from 0.1g to 1.1g peak ground acceleration, with each earthquake test preceded and followed by low-amplitude white noise excitations (0.08g) to monitor changes in dynamic properties. The testing campaign comprised eleven tests total (ST1-ST11 see Table 1), systematically increasing the seismic demand to achieve serviceability limit state damage levels in the reinforced concrete structure (serious damage of infill walls while maintaining steel reinforcement strains below yielding).

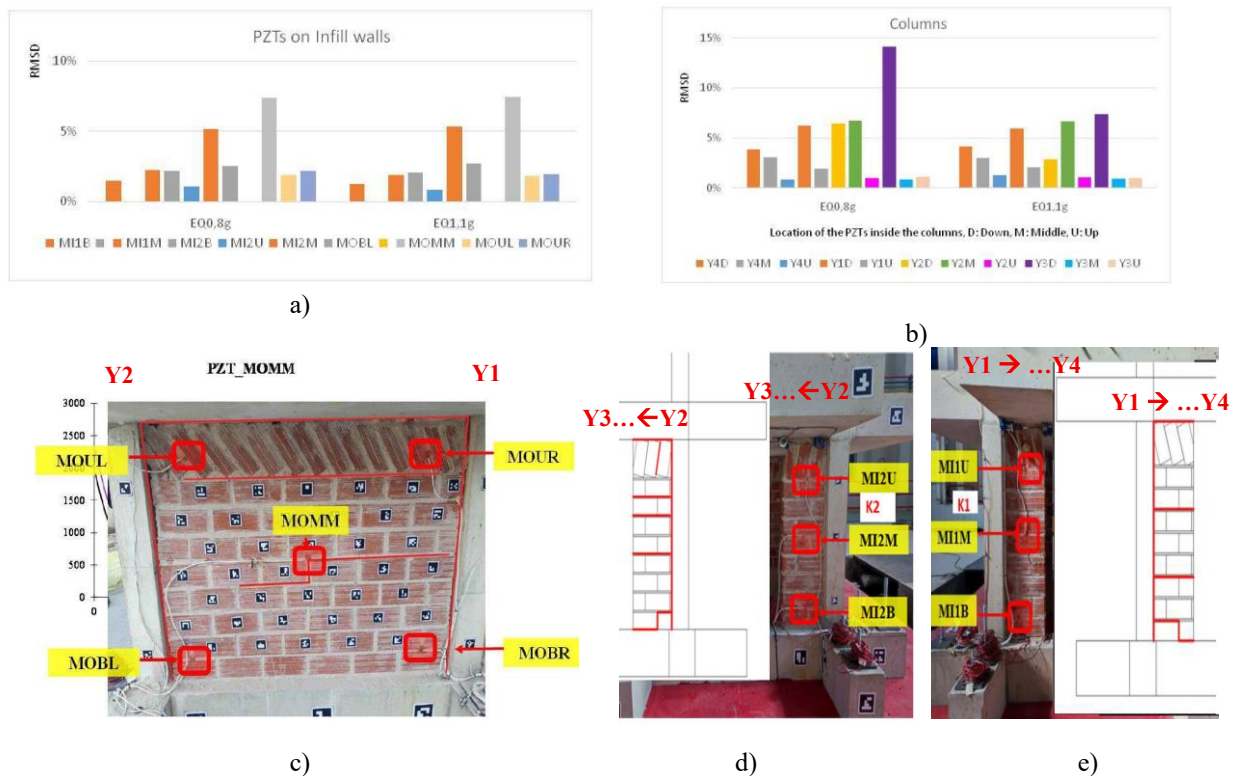
Figure 7: Damage details for a) PZTs on infill walls, b) PZTs on columns and visual damage observation on infill between c) columns 1-2, d) columns 2-3 and e) columns 1-4

The structure remained undamaged through initial serviceability levels (EQ0.1g and EQ0.2g excitations), with no visual damage or elevated RMSD values detected. The first brick infill serviceability limit state threshold was reached at EQ0.5g excitation (ST6), where initial damage accumulation commenced in infill wall 3-4, coinciding with the first appearance of elevated RMSD values from PZT sensors on infill walls (see Figure 7a). Progressive RC serviceability limit states at EQ0.8g and EQ1.1g excitations revealed systematic damage escalation: infill walls developed extensive horizontal and diagonal crack patterns with wall-to-frame debonding (see Figure 7d-e), while columns exhibited minor edge cracking at critical sections. The PZT monitoring system effectively captured this damage progression, with RMSD values increasing proportionally across different RC serviceability levels (see Figure 7b). Infill wall sensors recorded the highest RMSD increases in central areas where major horizontal cracks developed, while column sensors showed elevated values particularly in lower regions corresponding to observed cracking (see Figure 7c-e).
